West Saline Water Users

CONDITION ASSESSMENT REPORT

Tank 1 Caldwell

100,000 Elevated

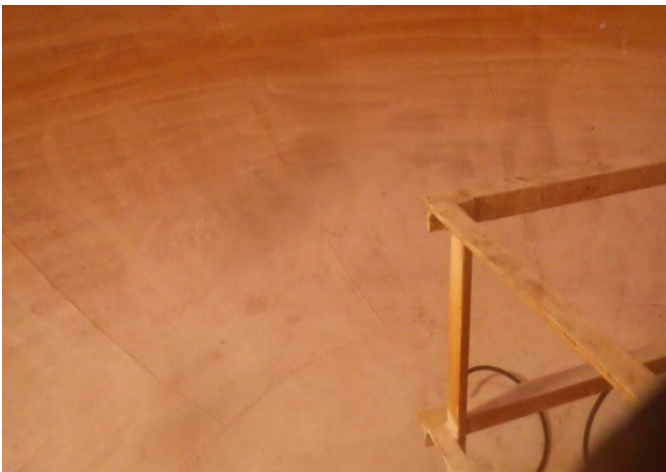
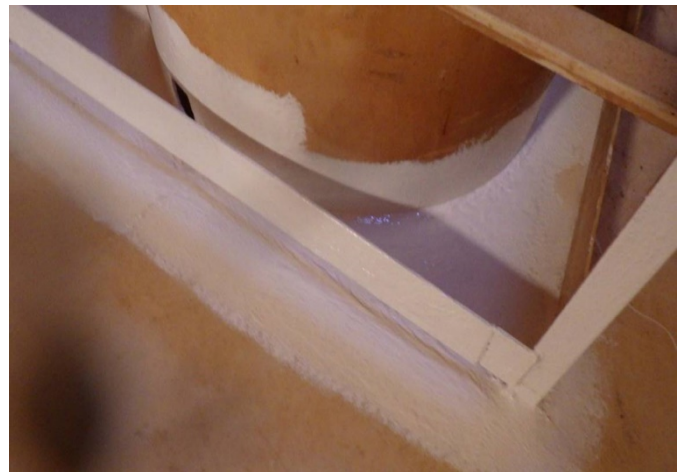
- **Interior Coating Condition:** Interior coating is in good condition and continues to protect the substrate.
- **Exterior Coating Condition:** No deficiencies noted in the exterior coating.

Interior Coating Bowl

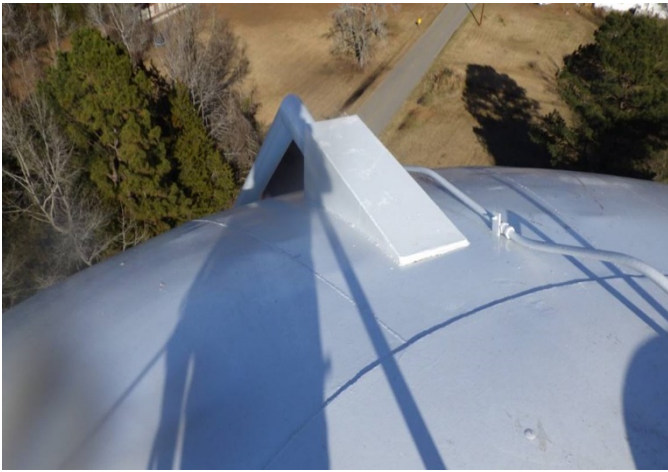
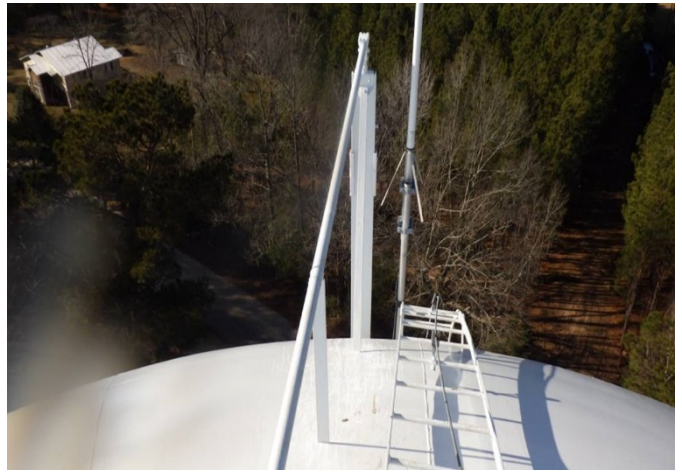
Exterior Coating Roof

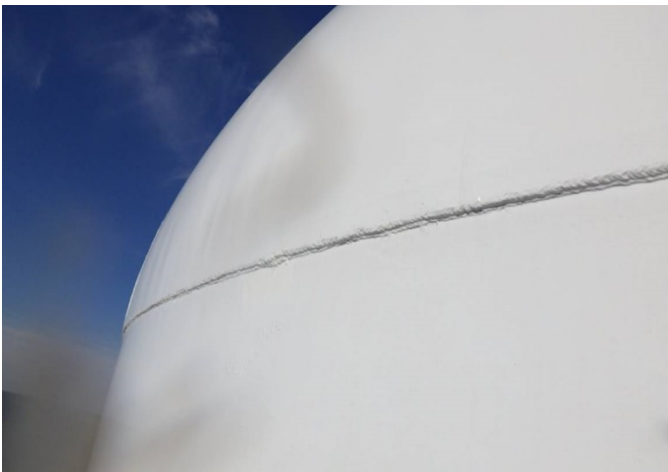
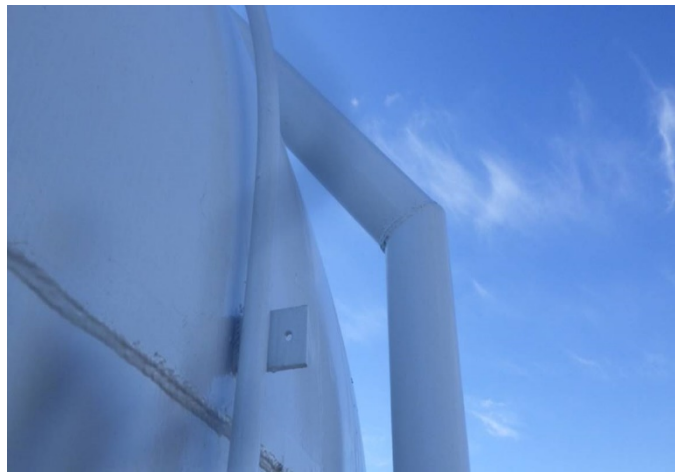
Exterior Coating Sidewall

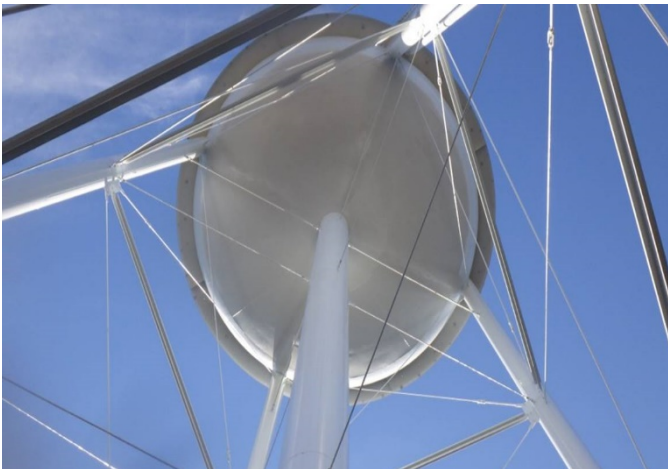
Exterior Coating Under Belly

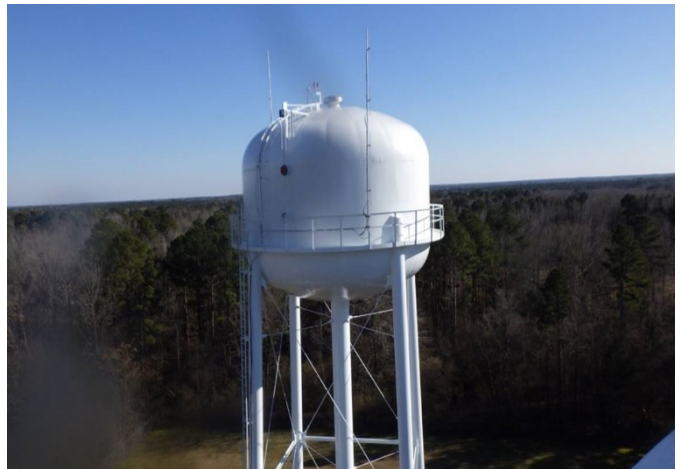
Exterior Coating Bowl

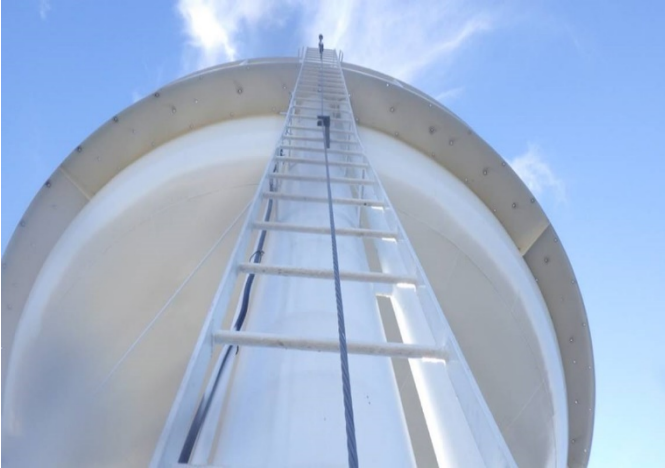
Safety Climb on Access Ladder

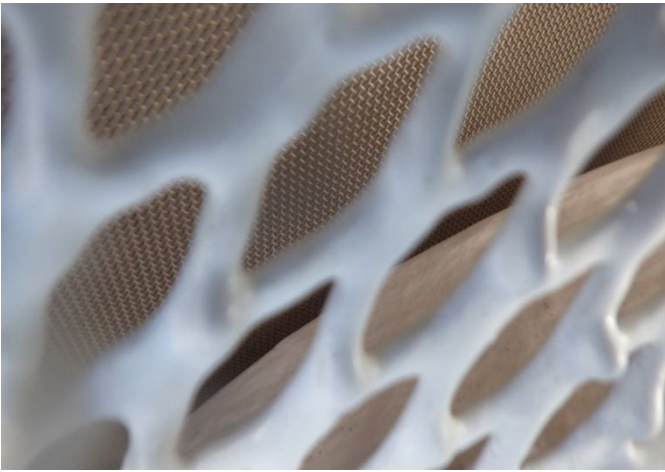
Vent Screen

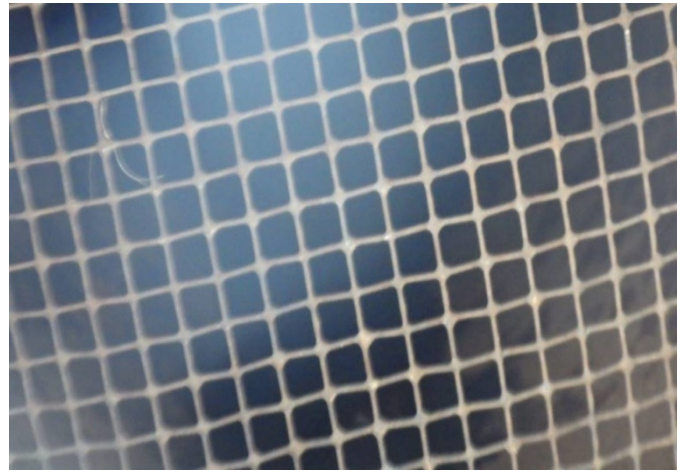
Overflow Screen

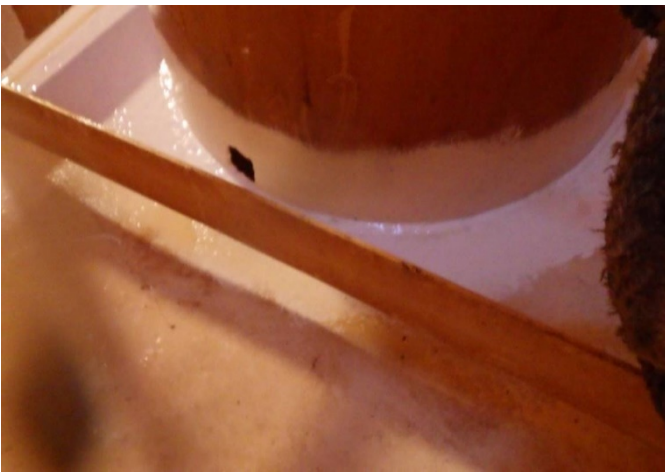
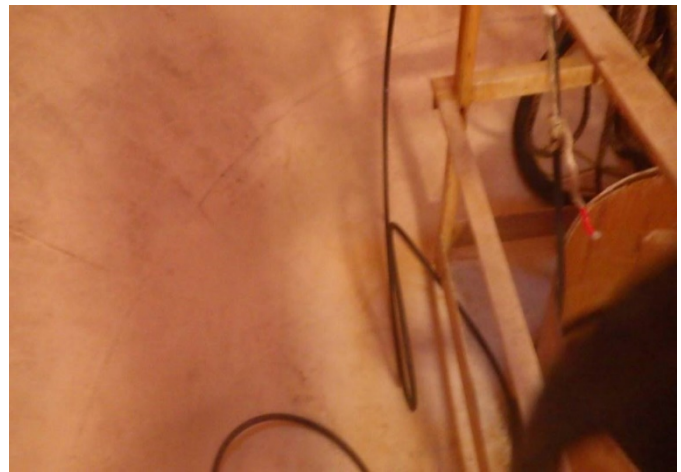
Post-Washout Interior

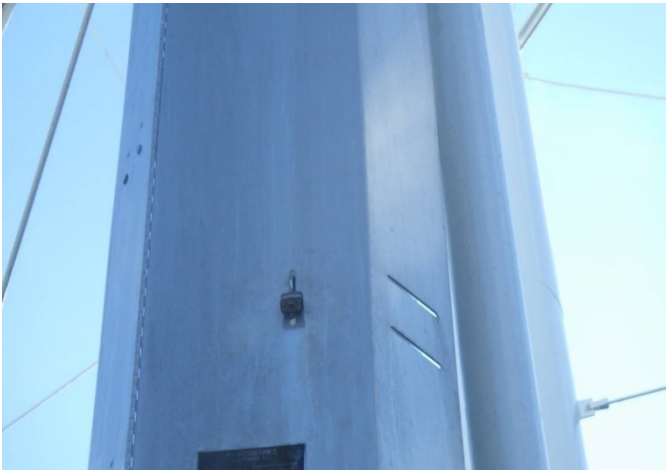
Ladder Guard Locked

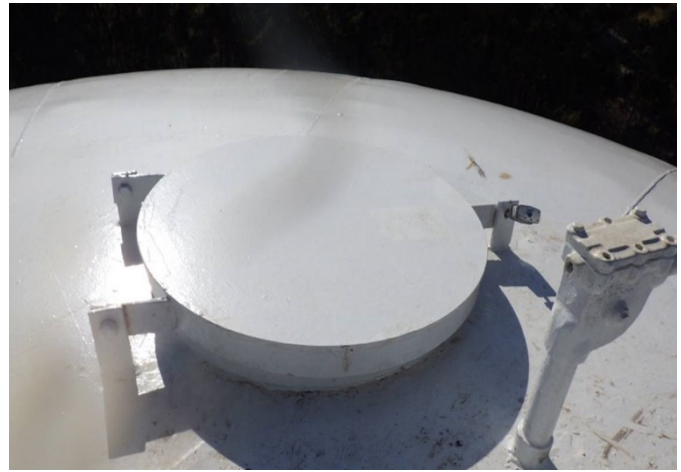
Access Hatch Locked

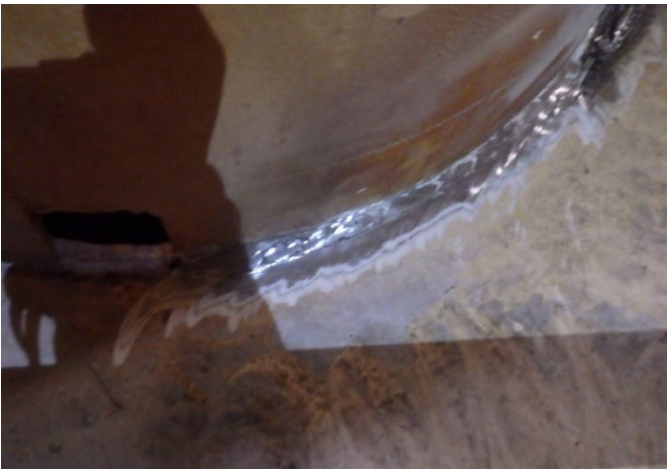
- **Welds:** Pitting and cracking noted in one or more weld seams. Repair was completed during the inspection. No other deficiencies noted.
- **Float System:** Float system is in working condition. No deficiencies noted.

Bowl/Riser Connection Repairs Prior Painting
