West Saline Water Users

CONDITION ASSESSMENT REPORT

Tank Name:
Tank 2 Phoenix

Inspection Date:
January 26, 2021

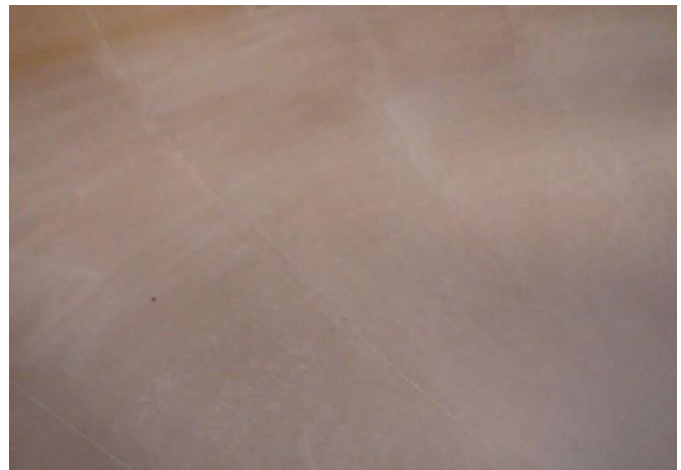
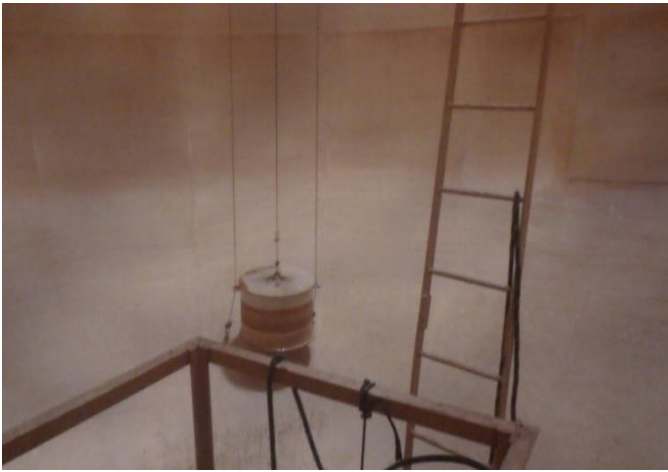
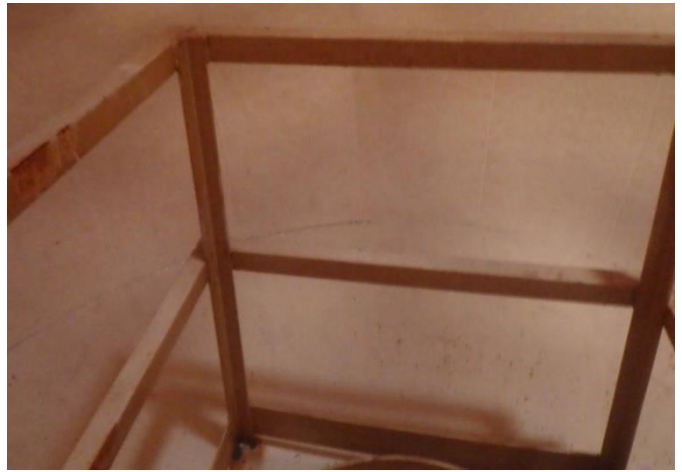
- **Interior Coating Condition:** Interior coating is in good condition and continues to protect the substrate.
- **Exterior Coating Condition:** No deficiencies noted in the exterior coating.

Interior Coating Bowl

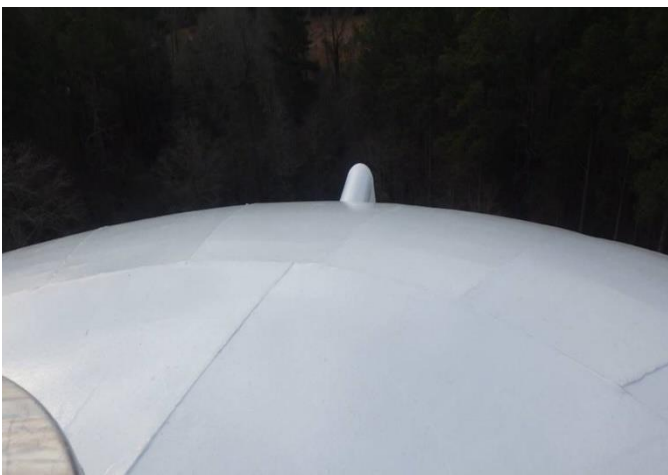
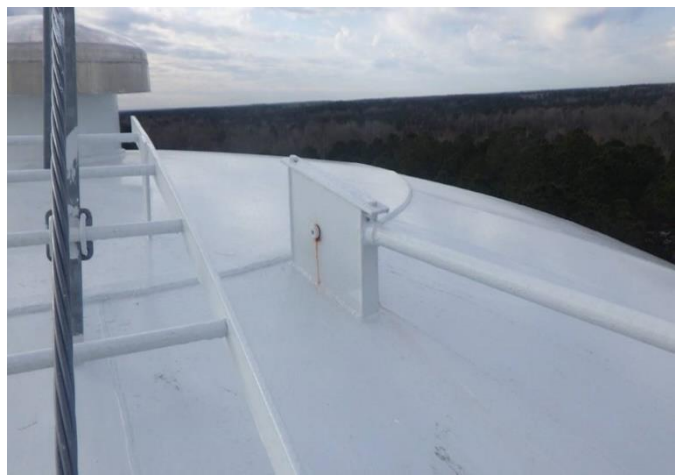
Exterior Coating Roof

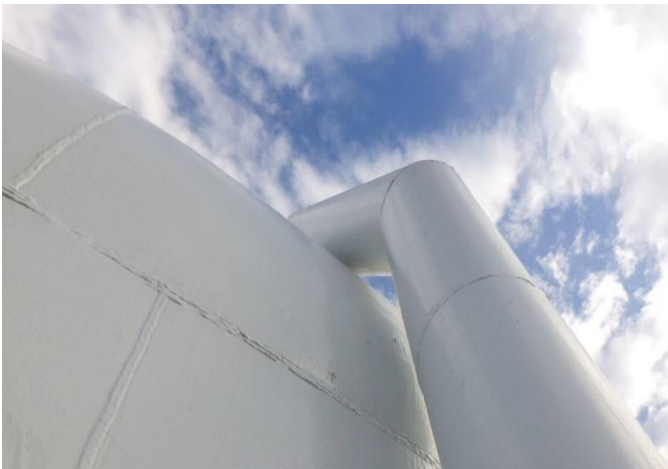
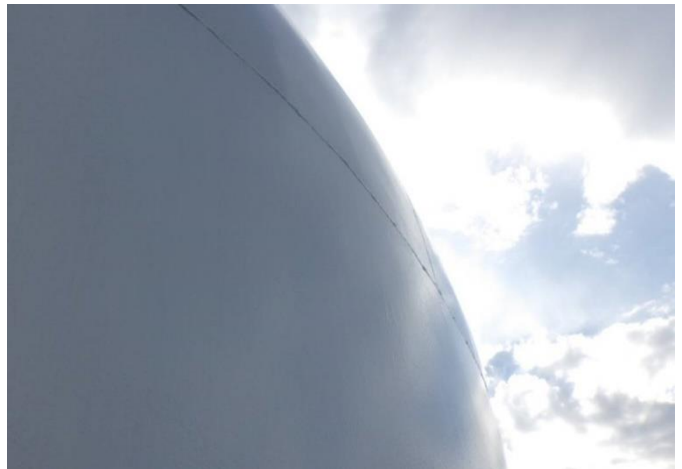
Exterior Coating Sidewall

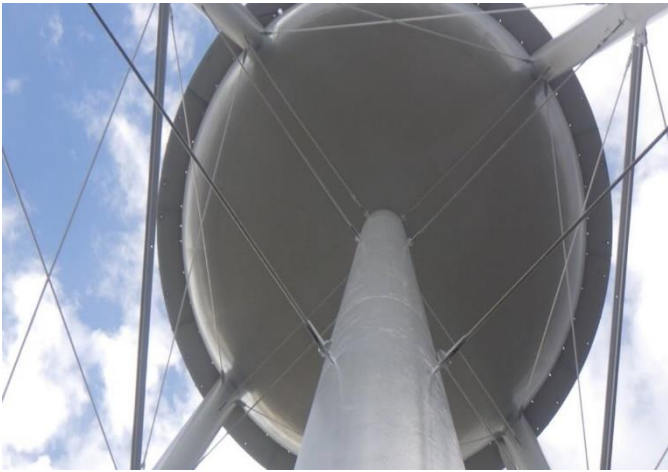
Exterior Coating Under Belly

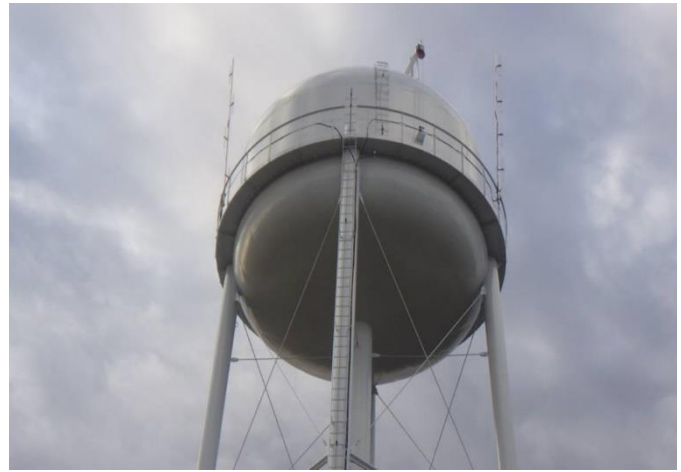
Exterior Coating Bowl

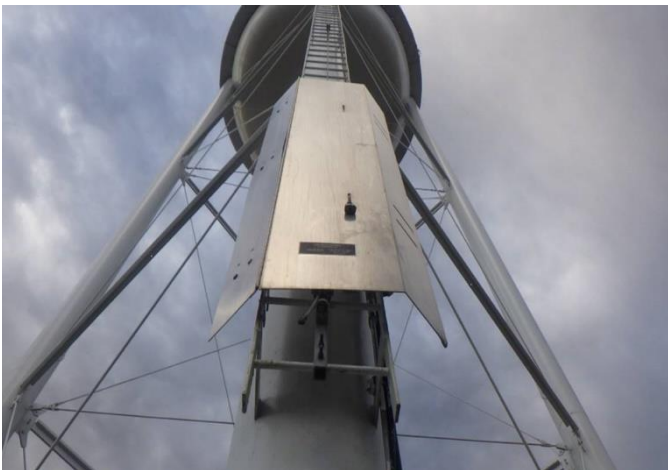
Safety Climb on Access Ladder

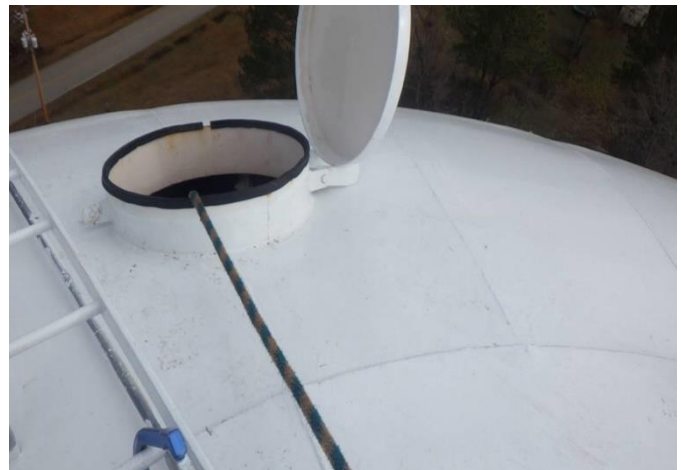
- **Safety Climbing Devices:** Ladders are equipped with secured safety climb devices.
- **Access Hatch1:** Main wet interior roof access hatch is showing minor corrosion on the interior portion of the lid. A new gasket was installed around the lip of the access hatch.

Wet Interior Access Hatch Open

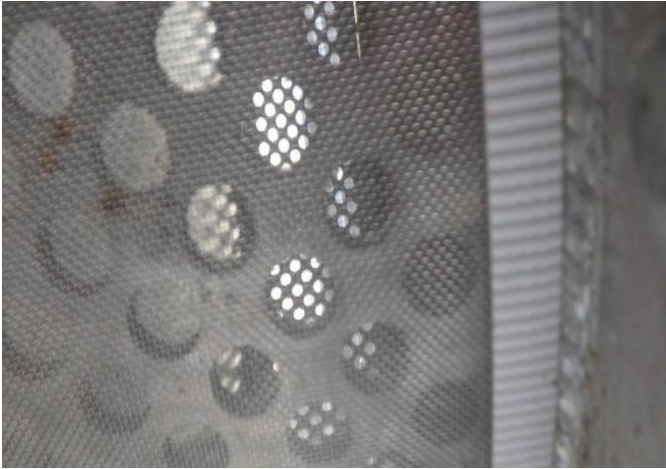
Vent Screen

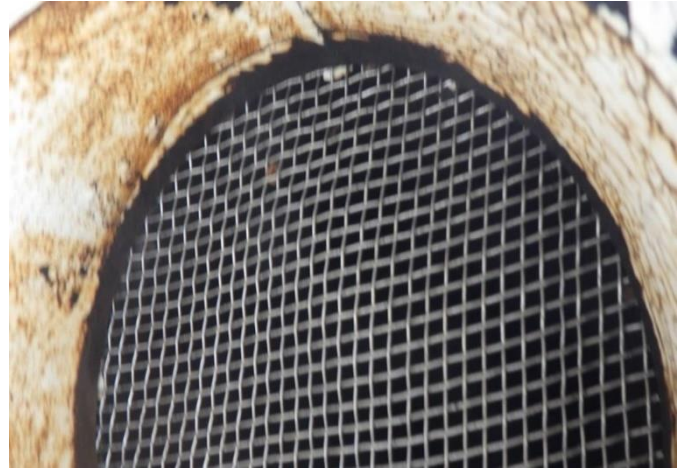
Overflow Screen

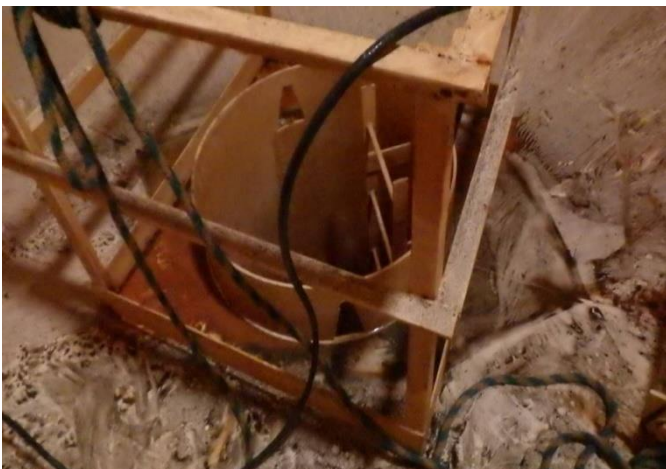
Pre-Washout Sediment

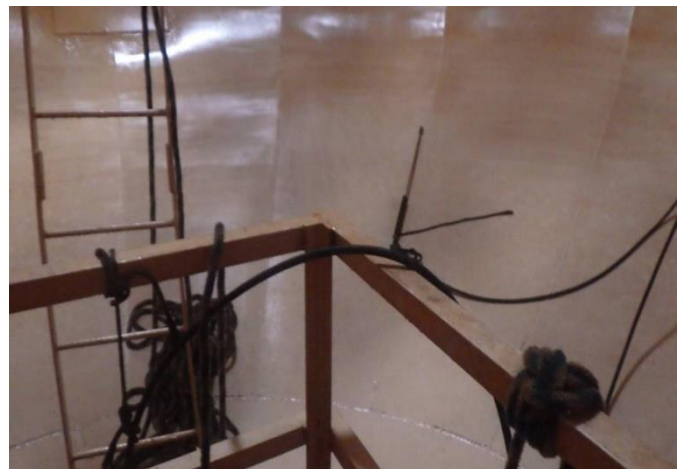
Post-Washout Interior

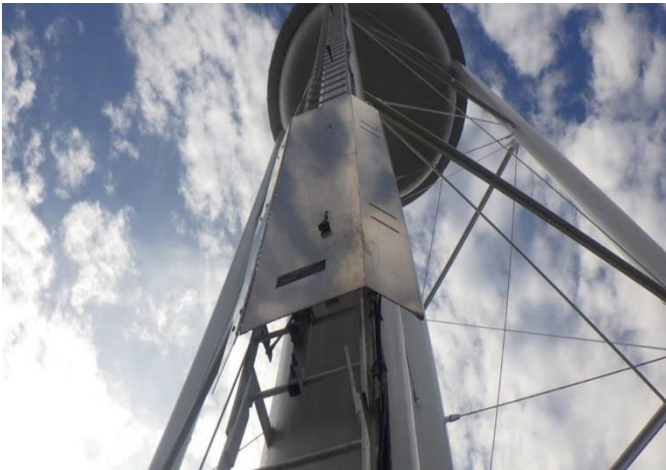
Ladder Guard Locked

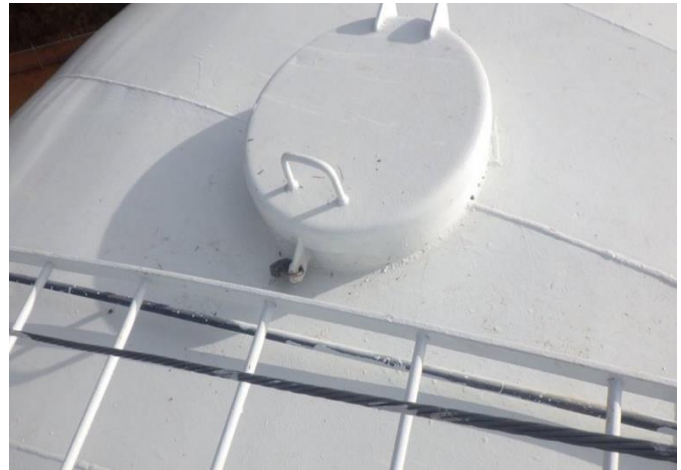
Access Hatch Locked

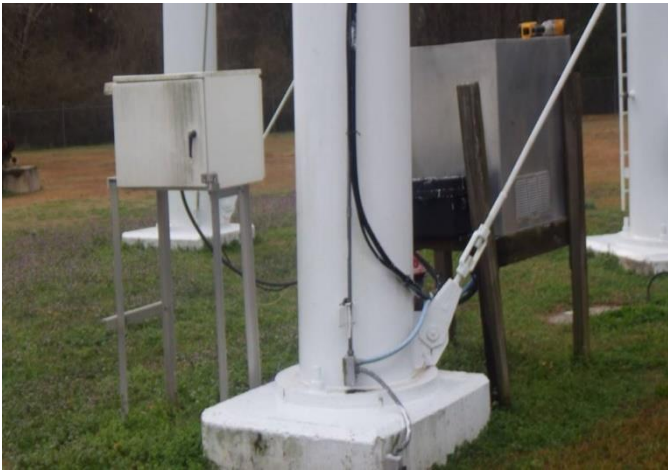
Leg Structure

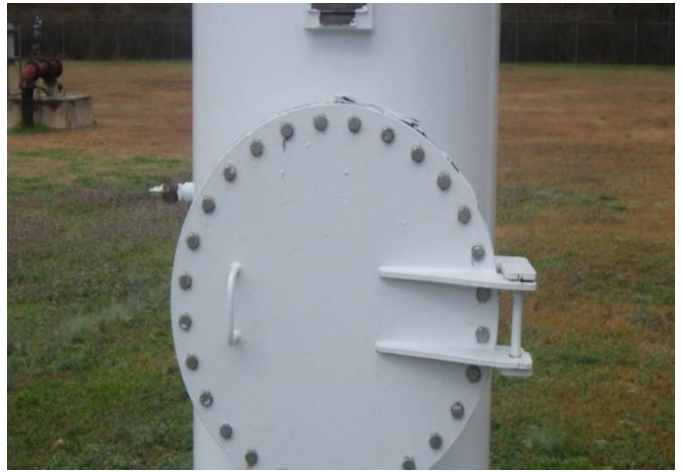
Riser Manway

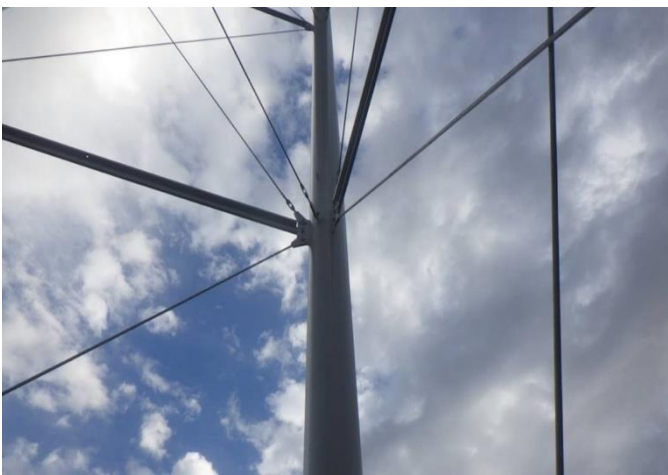
Strut Connections

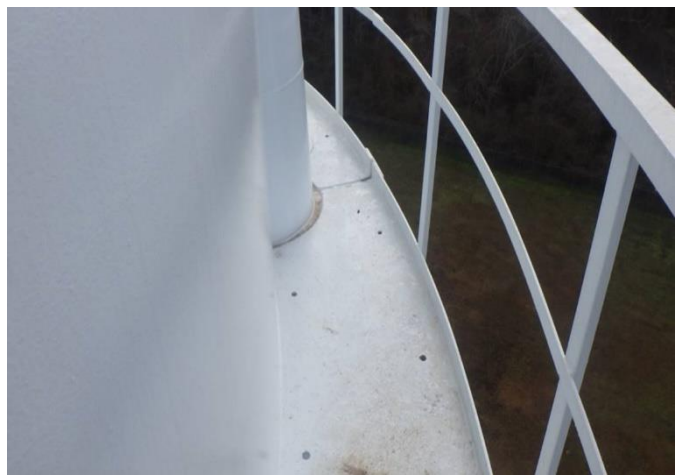
Balcony

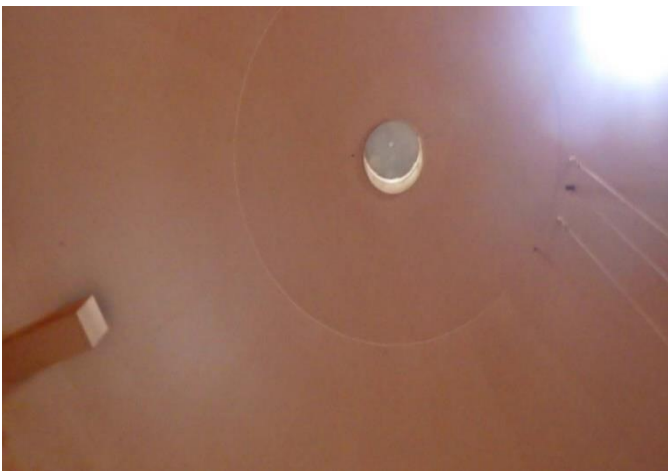
Interior Roof Structure

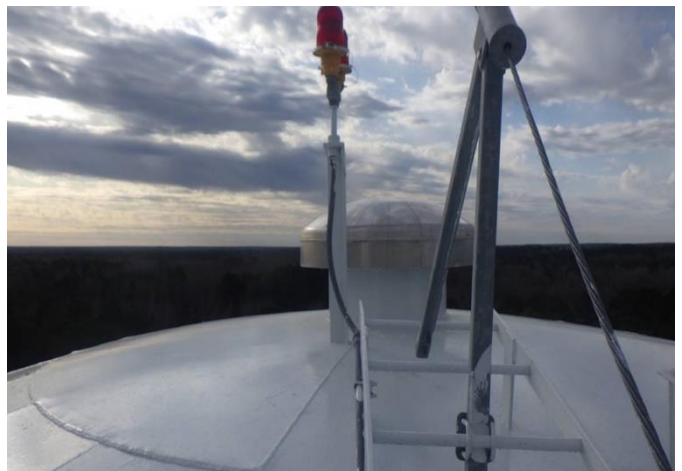
Vent Structure
