# West Saline Water Users

## CONDITION ASSESSMENT REPORT

**Tank Name:**  
Tank 3 Tinsman 30kg

**Inspection Date:**  
January 20, 2021

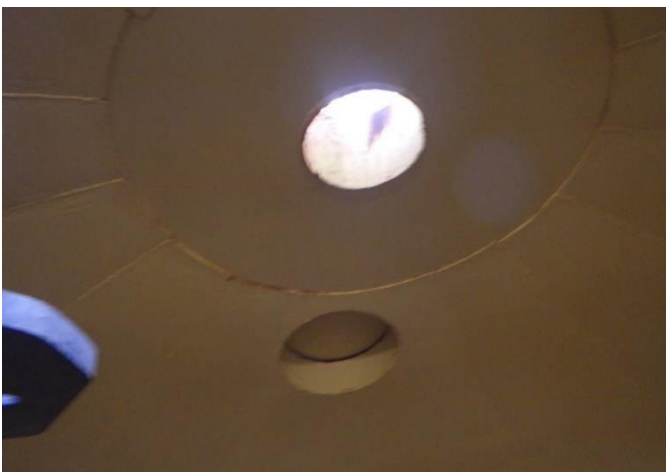
Interior Coating Roof

- **Interior Coating Condition:** Interior coating is in overall good condition and continues to protect the substrate. Minor deficiencies noted on the roof, and will continue to be monitored.
- **Exterior Coating Condition:** No deficiencies noted in the exterior coating.
- **Logo Condition:** No deficiencies noted.

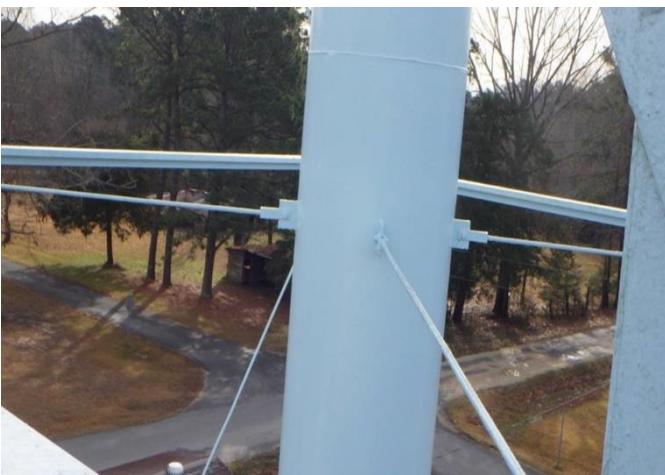
Exterior Coating Riser

- **Anchor Bolts:** Anchor bolts are protected and show no rust or corrosion.
- **Riser Pipe:** No deficiencies noted with riser. Paint coating continues to protect the substrate.

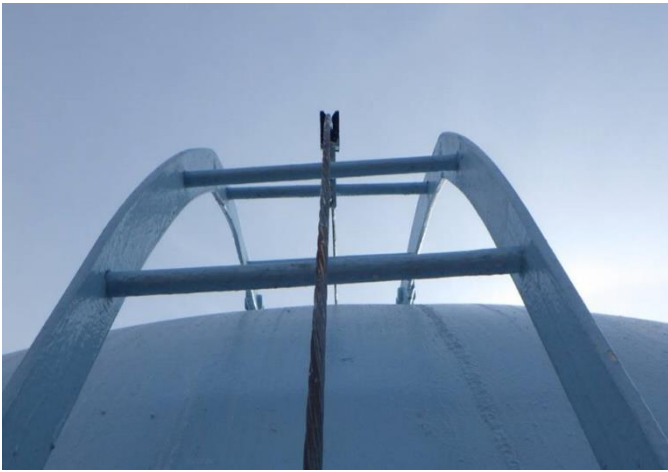
Safety Climb on Access Roof Ladder

- **Safety Climbing Devices:** Ladders are equipped with secured safety climb devices.
- **Access Hatch1:** Main wet interior roof access hatch is showing minor corrosion on the interior portion of the lid. Areas will continue to be monitored.
- **Access Hatch2:** Secondary wet interior roof hatch is bolted access. Structure is in good condition.

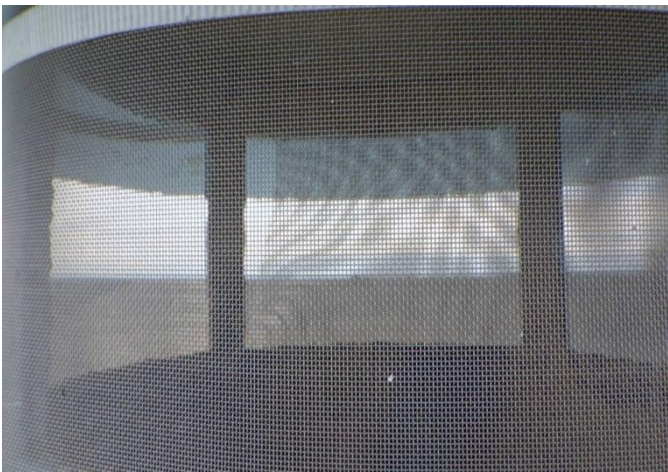
Vent Screen

- **Vent Screen:** No deficiencies noted with vent screen.
- **Overflow Pipe Screen Flapper:** Overflow pipe is equipped with flap gate and screen. No deficiencies noted with flapper.
- **Evidence Of Foreign Matter:** No evidence of foreign matter observed.
- **Sediments:** Light sediment in bottom of tank was cleaned out with pressure washing.

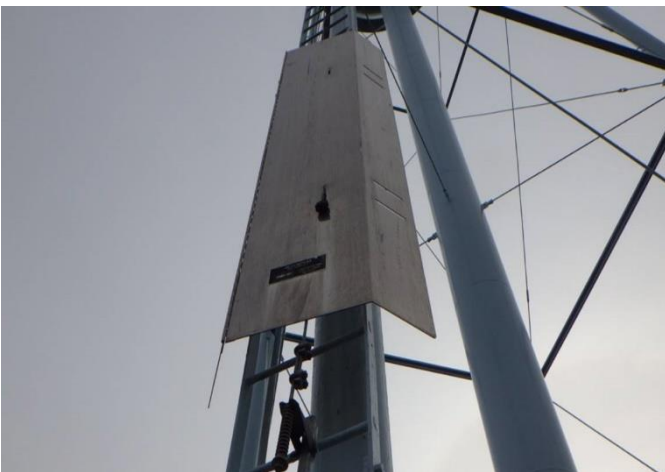
Ladder Guard Locked

- **Fence Around Site:** Tank is located inside a fenced-in area that is secure.
- **Ladder Gate/Access Door:** Exterior ladder has a ladder gate installed and is locked.
- **Access Hatch Locked:** Access hatch is locked and secured.
- **Evidence Of Vandalism:** No evidence of vandalism was found.

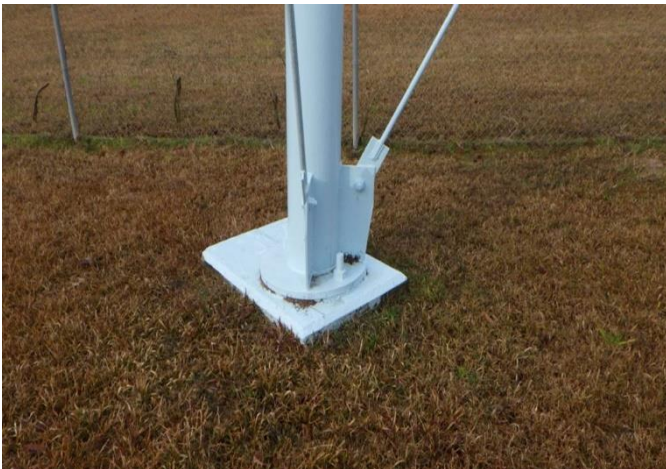
Leg Structure

- **Foundation:** Foundation appears in good condition. No deficiencies noted.
- **Legs:** No deficiencies noted with tank legs. Paint coating continues to protect the substrate.

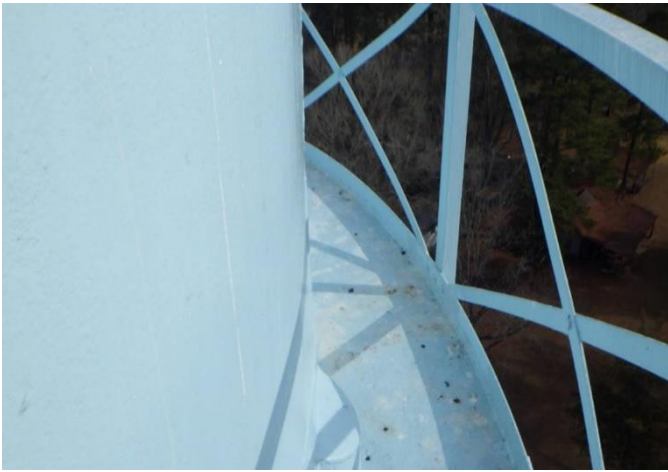
Balcony

- **Balcony:** No deficiencies or corrosion damage noted for balcony railings and landings.
- **Interior Ladders:** The interior ladder shows minor corrosion of the structure. Areas will continue to be monitored.

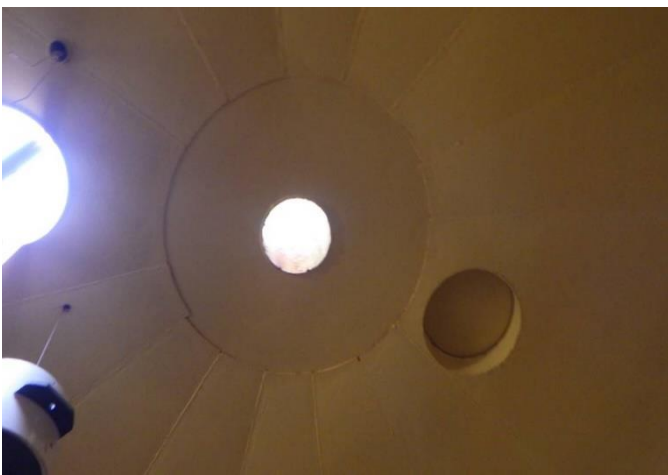
Interior Roof Structure

- **Roof:** Minor rust streaking/staining and spot corrosion was present on the roof. Areas will continue to be monitored.
- **Vents:** No deficiencies noted with vent.
