West Saline Water Users

CONDITION ASSESSMENT REPORT

Tank Name:
Tank #1 (Caldwell)

Inspection Date:
April 10, 2018

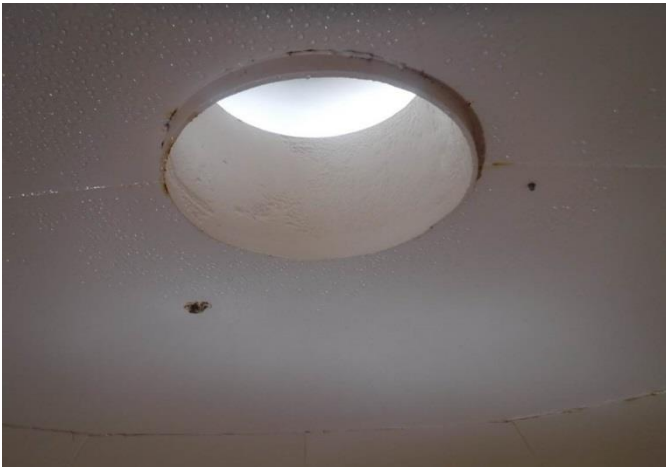
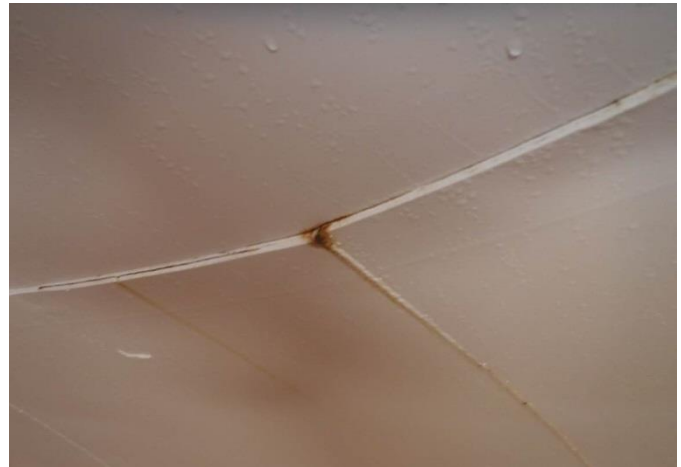
Interior Coating Roof

- **Interior Coating Condition:** Spot corrosion and minor rust streaking/staining deficiencies were noted with the interior coating. Areas will continue to be monitored.
- **Exterior Coating Condition:** Coating is faded with mildew present on the exterior. Due to the age and condition of the coating, an exterior renovation will be scheduled.

- **Roof:** Minor rust streaking/staining and spot corrosion was present in on the roof. Areas will continue to be monitored.
- **Vents:** No deficiencies noted with vent.

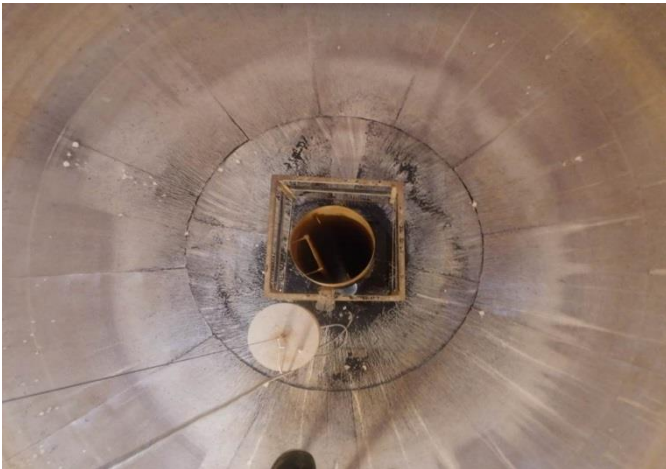
Pre-Washout Sediment

- **Vent Screen:** No deficiencies noted with vent screen.
- **Overflow Pipe Screen Flapper:** Overflow pipe is equipped with flap gate and screen. No deficiencies noted with flapper.
- **Evidence Of Foreign Matter:** No evidence of foreign matter observed.
- **Sediments:** Heavy sediment in bottom of tank was cleaned out with pressure washing. Some brown mineral stain still remains.
