West Saline Water Users

CONDITION ASSESSMENT REPORT

Tank 1 Caldwell

100,000 Elevated

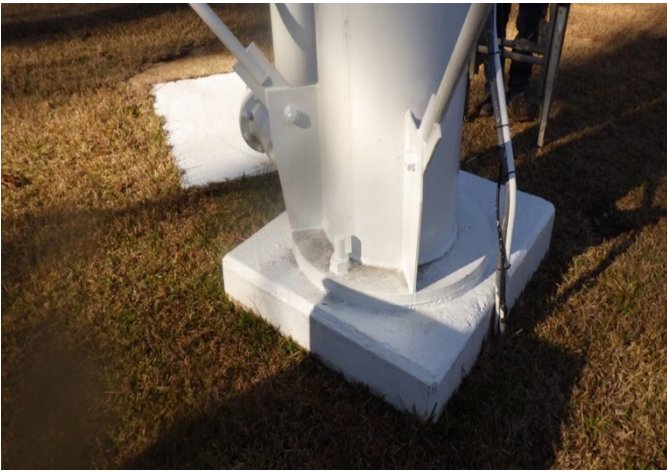
Leg Structure

- **Foundation:** Foundation appears in good condition. No deficiencies noted.
- **Legs:** No deficiencies noted with tank legs. Paint coating continues to protect the substrate.

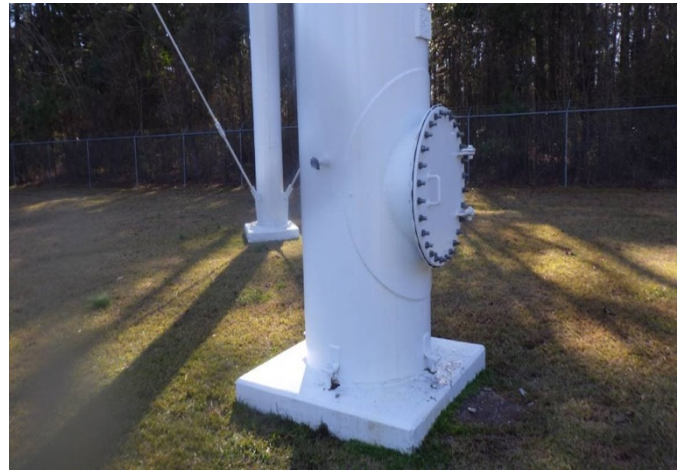
Riser Manway

- **Riser Rods:** No deficiencies noted with riser rods.
- **Wind Rods:** No deficiencies noted with wind rods.
- **Watertight Conditions:** There are no visible leaks at manway, riser or legs.

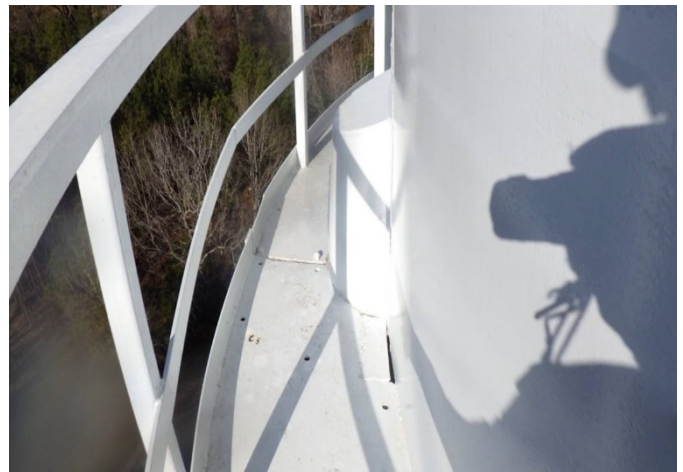
Balcony

- **Balcony:** No deficiencies or corrosion damage noted for balcony railings and landings.
- **Interior Ladders:** No deficiencies noted for the interior ladder stiles, rungs and connections.

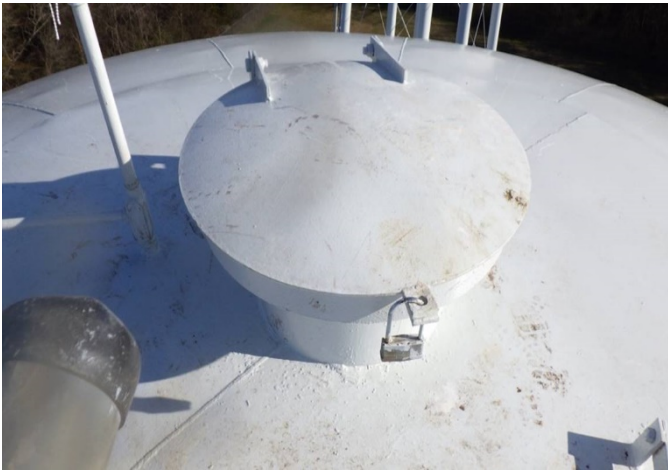
Vent Structure

- **Roof:** The interior roof does not have roof beams. No deficiencies noted.
- **Vents:** No deficiencies noted with vent.
- **Overflow Pipe:** No deficiencies noted. Overflow pipe extends to ground level.
