West Saline Water Users

CONDITION ASSESSMENT REPORT

Tank Name:
Tank #1 (Caldwell)

Inspection Date:
April 10, 2018

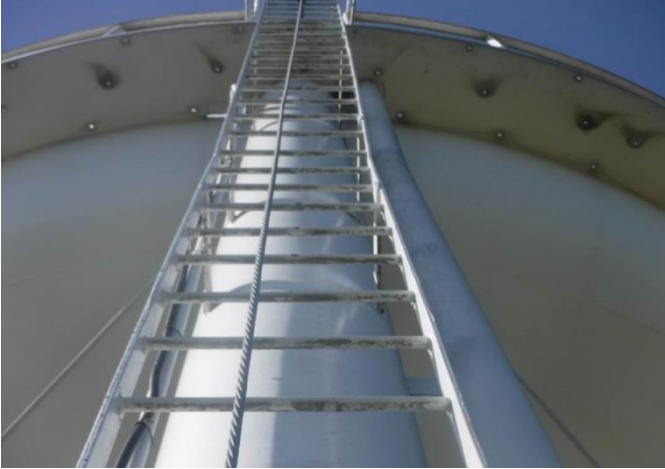
Safety Climb on Access Ladder

- **Safety Climbing Devices:** Ladders are equipped with secured safety climb devices.
- **Access Hatch1:** No deficiencies noted.

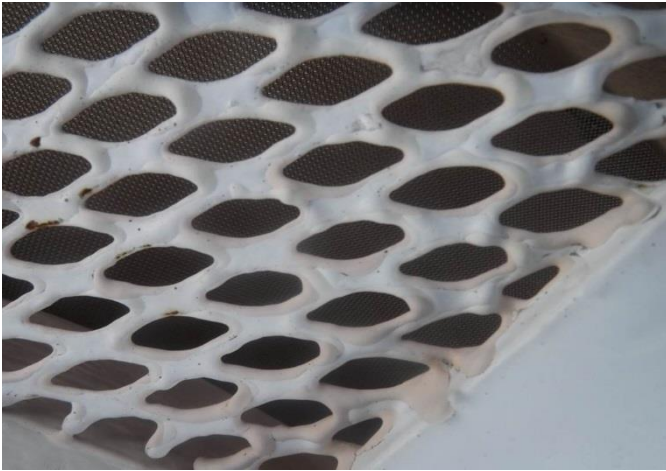
Vent Screen

- **Vent Screen:** No deficiencies noted with vent screen.
- **Overflow Pipe Screen Flapper:** Overflow pipe is equipped with flap gate and screen. No deficiencies noted with flapper.
- **Evidence Of Foreign Matter:** No evidence of foreign matter observed.
- **Sediments:** Heavy sediment in bottom of tank was cleaned out with pressure washing. Some brown mineral stain still remains.

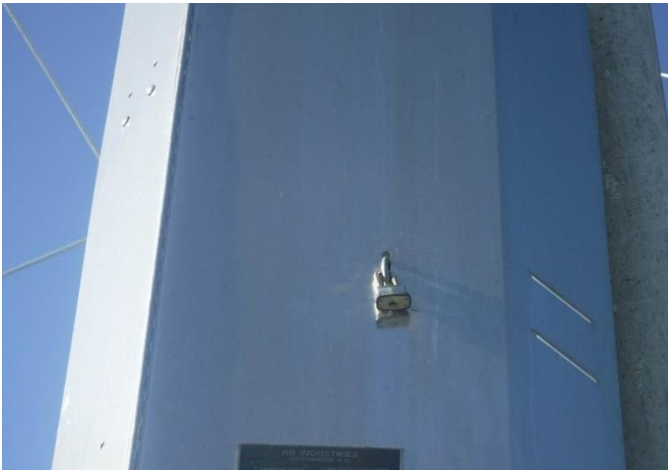
Ladder Guard Locked

- **Fence Around Site:** Tank is located inside a fenced-in area that is secure.
- **Ladder Gate/Access Door:** Exterior ladder has a ladder gate installed and is locked.
- **Access Hatch Locked:** Access hatch is locked and secured.
- **Evidence Of Vandalism:** No evidence of vandalism was found.

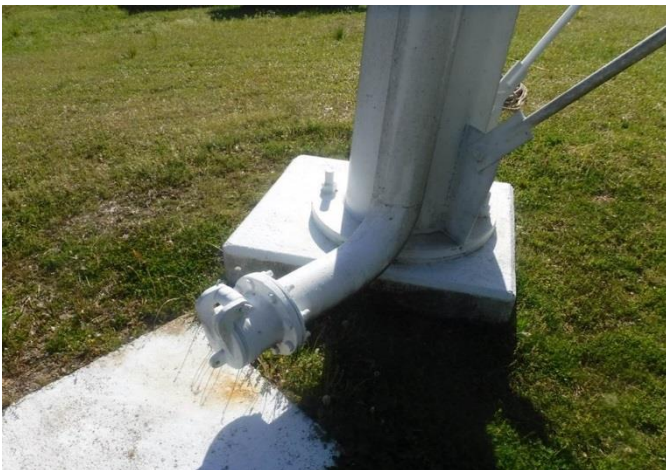
Leg Structure

- **Foundation:** Foundation appears in good condition, but erosion is occurring around the foundation.
- **Legs:** No deficiencies note with tank legs. Paint coating continues to protect the substrate. Light mildew exists on structure.

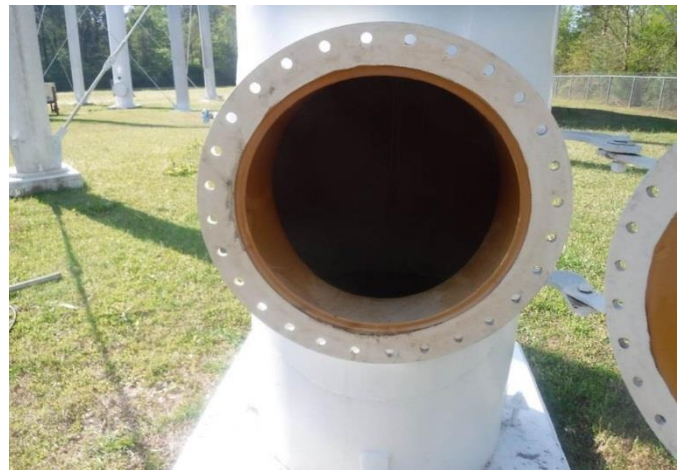
Riser Manway

- **Anchor Bolts:** Anchor bolts are protected and show no rust or corrosion.
- **Riser Pipe:** No deficiencies noted with riser. Paint coating continues to protect the substrate.

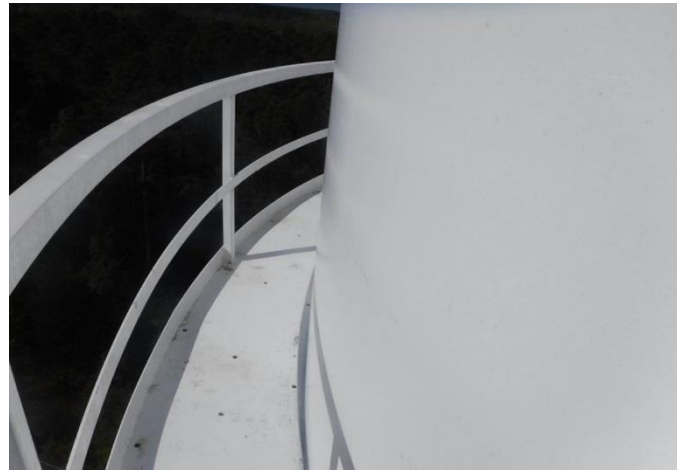
Balcony

- **Balcony:** No deficiencies or corrosion damage noted for balcony railings and landings.
- **Interior Ladders:** No deficiencies noted for the interior ladder stiles, rungs and connections.
